**Technical Memorandum****URS OPERATING SERVICES****Containment of sources****Upper Animas Mining District, San Juan County, Colorado**

Date: January 20, 2012

**Introduction**

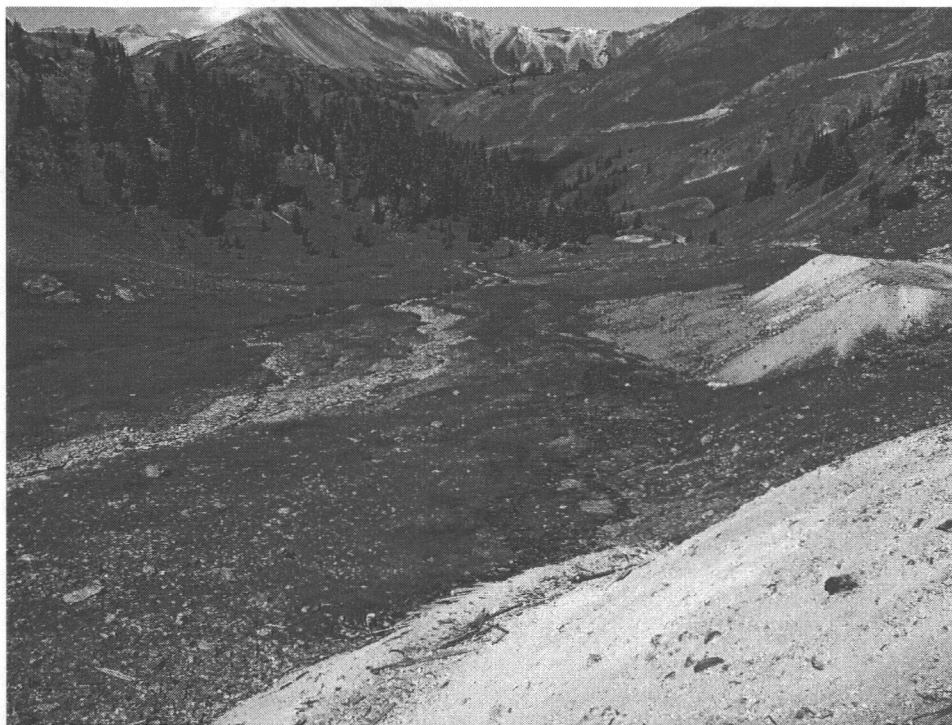
**Grand Mogul Mine:** The Grand Mogul Mine source area consists of three waste rock piles and an aqueous discharge that begins at the toe of the east waste rock pile and flows generally to the west, along the toe of the pile (Photo 1) before joining Cement Creek. It is presumed that the discharge originates at a collapsed or buried adit beneath the east pile.

**Grand Mogul Mine:** The Grand Mogul waste piles did not have an engineered cover and were not vegetated (Photo 1). Any precipitation that falls on either pile would either flow down the surface of the pile or percolate into the material. No evidence of an engineered liner was observed and no functioning leachate collection and removal system associated with the pile was noted. No run-on control system was in place and the discharge that begins at the toe of the east pile flows directly adjacent to the base of the west pile (Photo 1).

**Photo 1:** East (bottom right) and west (middle right) waste rock piles of the Grand Mogul Mine source. Note discharge that originates at the bottom of the east pile where Jeff Miller (UOS) is standing, and discharges into Cement Creek in the middle of the photo. Looking west-northwest.

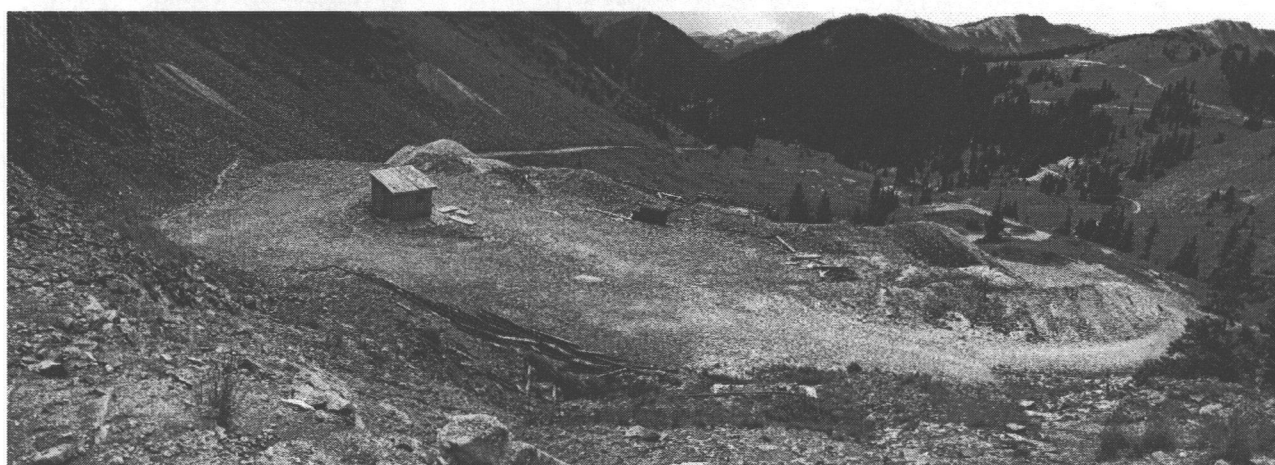
**Mogul Mine:** The Mogul Mine source area consists of an open adit on the northeast side of a waste rock pile (Photo 2). The adit discharge flows south across the top of the waste rock pile in a tarp-lined ditch, then flows across the mine waste rock to an access road at a point at the southeast corner of the waste pile. Once the adit discharge crosses the road, it flows west-southwest over a mixture of mine waste rock and mine trash into a series of wetlands below the mine before joining Cement Creek.

**Mogul Mine:** The Mogul Mine waste rock pile did not have an engineered cover and was not vegetated (Photo 2). Any precipitation that falls on the pile would either flow down the surface of the pile or percolate into the material. Standing water was present on the flat upper surface of the pile during the site activities in August 2011 (Photo 2). No evidence of an engineered liner was observed and no functioning leachate collection and removal system associated with the pile was noted. The adit discharge flows south across the top of the waste rock pile within a tarp-lined ditch to an access road at a point at the southeast corner of the waste pile (Photo 2). The ditch tarp lining ends at the edge of the flat surface of the top of the pile. Once the adit discharge crosses the road, it flows southwest over a mixture of mine waste rock and timber into a series of wetlands below the mine, and then into Cement Creek.

**Photo 2:** Panoramic photograph of the Mogul Mine area. The adit discharge can be seen flowing along the base of the slope at the far left, which is the eastern edge of the waste rock pile. Cement Creek flows from the just off the bottom right of the photo to the upper middle of the photo. Looking southwest.

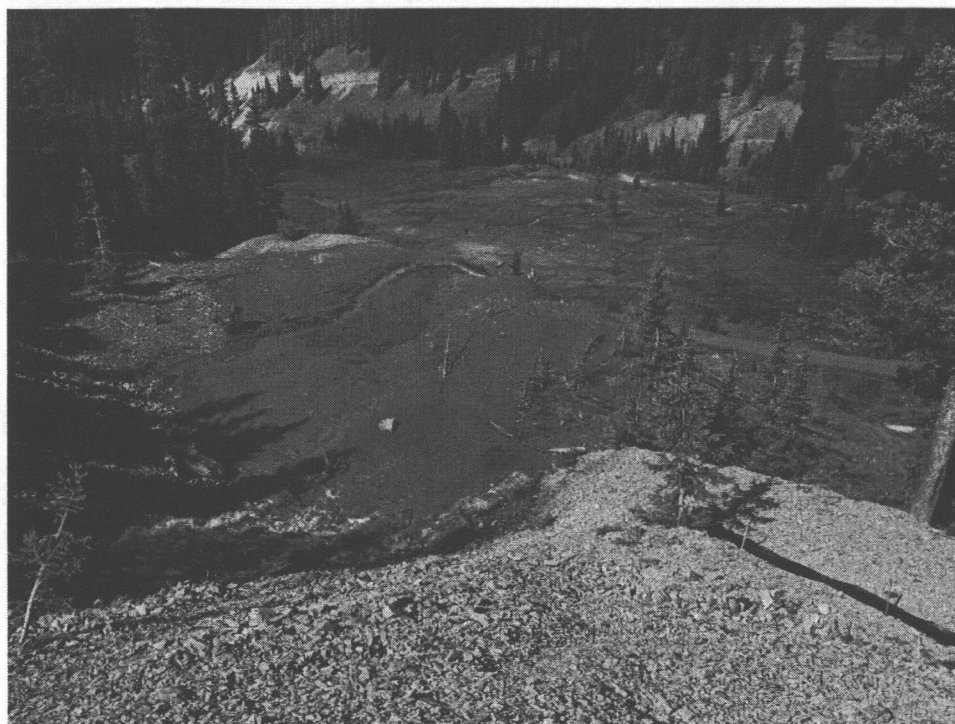
**Red and Bonita Mine:** The tiered waste rock at the Red and Bonita Mine did not have an engineered cover and was only sparsely vegetated by pine trees on the flatten top of the pile (Photo 3). Much of the pile is covered with an armored coating of iron oxide precipitates, deposited by the adit discharge. It is likely that the coating would prevent some degree of percolation into the pile from both the discharge and precipitation, but any precipitation falling on uncoated portions of the pile would either percolate into the material or flow down its surface. No run-on control system was in place and ponded water from the discharging adit was present on the flat upper surface of the pile during the site activities in August 2011. The discharge has eroded channels into the pile (Photo 3). No evidence of an engineered liner was observed and no functioning leachate collection and removal system associated with the pile was noted.

**Photo 3:** The top of the Red and Bonita Mine source area, showing the adit discharge (bottom left) and the top of the waste rock pile (bright red). The discharge flows down the face of the pile to the access road (middle right), where it flows to the left of the photo (south), and then crosses beneath the road through culvert. From the end of the culvert, the discharge continues generally west across a barren iron oxide stained area to Cement Creek (flow upper right to upper left). Looking west-southwest.

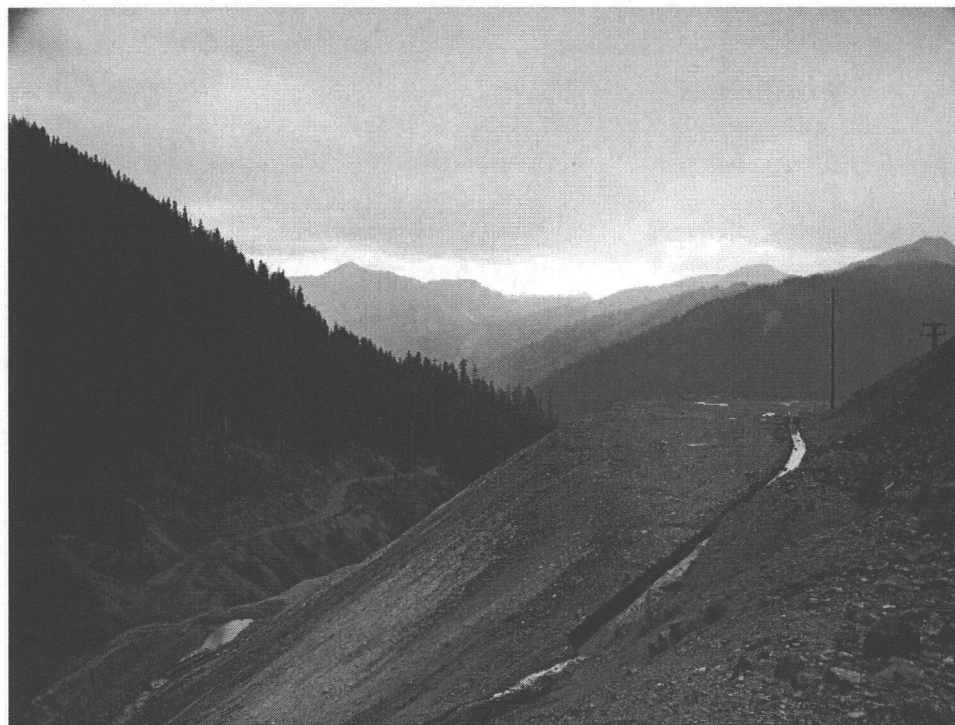
**Gold King 7 Level Mine:** The Gold King 7 Level Mine waste pile did not have an engineered cover and was not vegetated (Photo 4). Standing water was present on the flat upper surface of the pile during the site activities in August 2011 (Photo 4). Any precipitation that falls on the pile would either flow down the surface of the pile or percolate directly into the material. No evidence of an engineered liner was observed. Both adits (east and west) discharge at the top of the pile. The larger east discharge is directed into a segmented plastic culvert that flows to the east across the top of the pile to a point near the eastern edge of the waste rock (Photo 4). At this point, the discharge exits the culvert and cascades down the waste rock at the eastern edge of the pile, and into the North Fork of Cement Creek which flows to the west at the base of the pile. A small berm has been constructed between the pile and North Fork of

**Photo 4:** The top of the Gold King Level 7 Mine source area, showing the east adit discharge in a culvert (lower right), the end of the culvert (bottom center), and the small berm at the bottom of the pile (bottom left corner). Water ponding behind the berm breeches the berm and discharges into the North Fork of Cement Creek (flowing from the bottom left to the middle) just before the access road. Looking west.

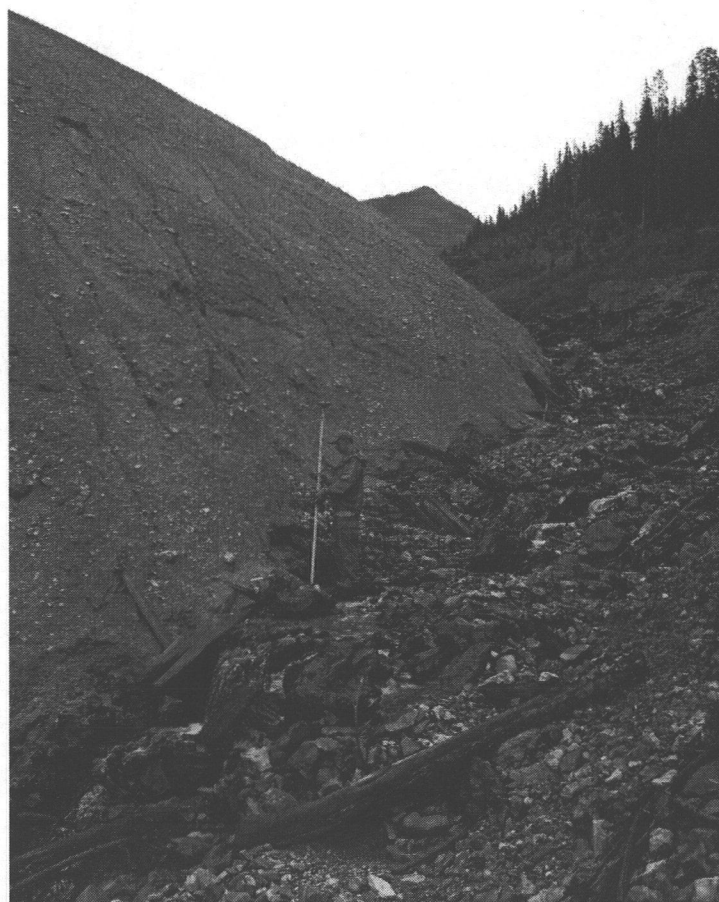
Cement Creek, but a portion of the adit discharge is captured behind this berm and the water eventually discharges through a breach in the berm into the creek, just before the access road (Photo 4). Beneath the access road, the creek is actively eroding the base of the pile (Photo 5). The smaller western discharge is not provided with any engineering controls and flows westward a short distance before percolating down through the waste rock pile and eventually into the North Fork of Cement Creek.

**Photo 5:** The bottom of the Gold King Level 7 Mine waste rock pile being actively eroded by the flow of the North Fork of Cement Creek. Jeff Miller (UOS) collecting GPS data from a sampling location.
